SPE SPE-156962-PP

An Analysis of the Caprock Failure at Joslyn

M.R. (Mike) Carlson, RPS Energy Canada Ltd.

This paper was prepared for presentation at the SPE Heavy Oil Conference Canada held in Calgary, Alberta, Canada, 12–14 June 2012.

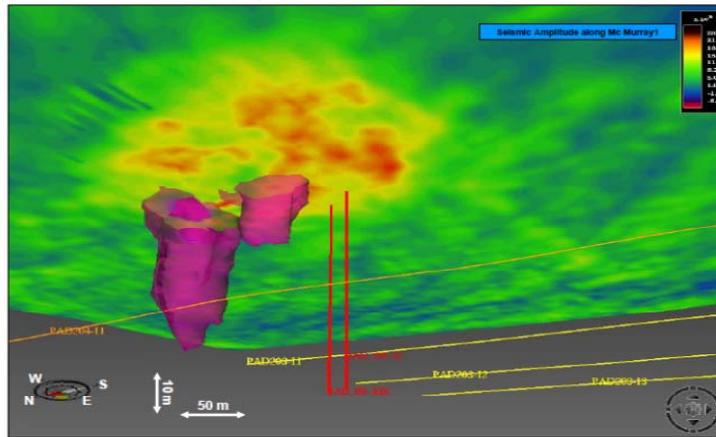
Figure-3 Joslyn Seismic 3D view from underneath

The picture from below would seem to indicate the existing vertical strat wells were not involved in the failure. More detail is provided in a cross-section. It is suggested in Total’s report that the fluid leakoff occurred in stages:

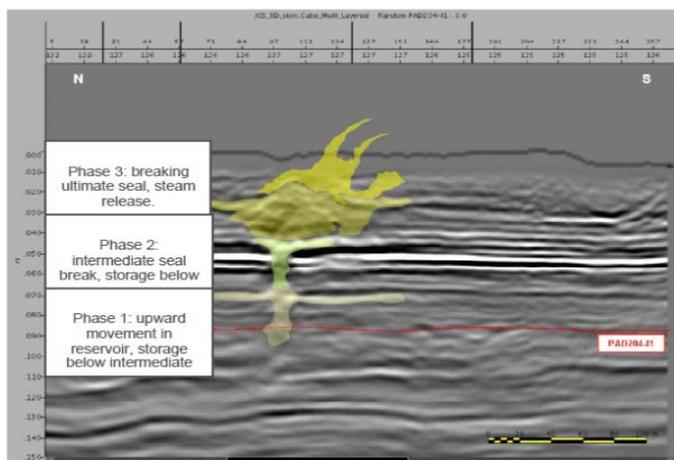
Figure-4 Joslyn Seismic Corss Section Showing Pipe

Figure 30 : Walking through the steam release on seismic – Phase 3. This phase corresponds to the ultimate step before and during the catastrophic steam release at surface.

The different phases are depicted in slightly different colours. The shape of this does not correspond to a simple vertical fracture or for that matter a simple horizontal fracture. It is also clear that there is some vertical feature. The features cuts across bedding planes that are quite well defined and suggests that whatever has caused the disturbance was most likely not stratigraphic. If a channel were to exist, its continuation would be visible elsewhere in seismic. The lateral distribution of disturbance, which indicates fluid movement, would have to be at high pressure to produce a leak-off pattern.

This type of fracture morphology is indeed seen in the 3D seismic depictions. However, Figure-4 shows that some significant dilation has taken place and this suggests some additional mechanism, either from the fracture directly or as a result of leak off from the fracture. The dilation chimney looks like what is known as a pipe in soil mechanics and represents a special stress condition.

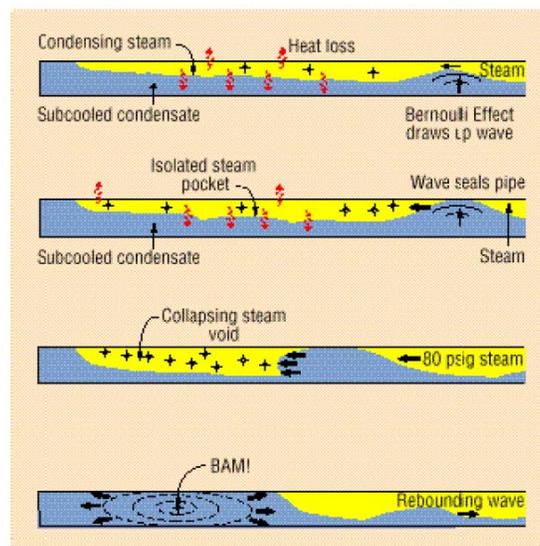
Figure-9 ERCB Explanaton of Condensation Induced Water Hammer (CIWH)

Figure 1. Condensation induced water hammer

In simplified terms, if steam injected into a line with cold water (condensate) can create a pressure wave large enough to burst line pipe, then the fracture pressure could be exceeded by over an order of magnitude (10 times). Since the liners are slotted, limited to no pressure drop would be expected between the wellbore and the formation.

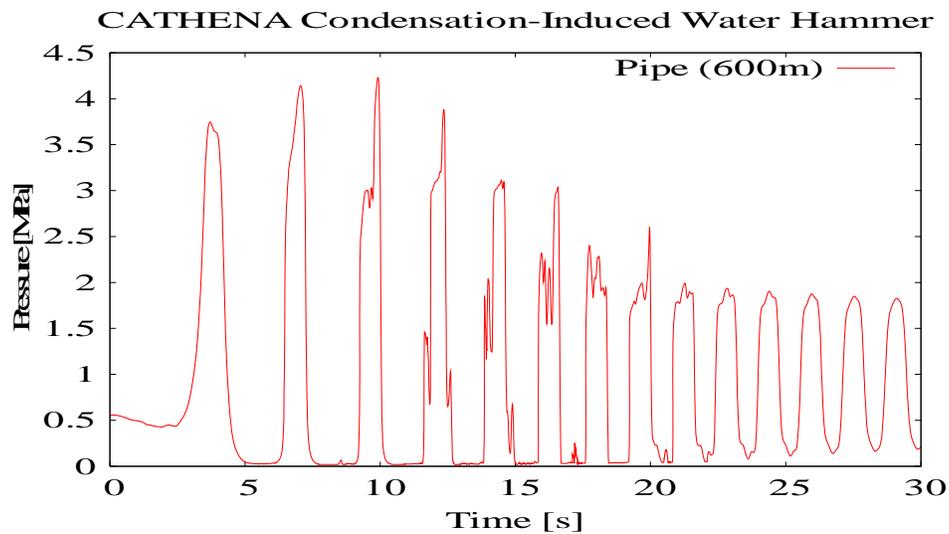
The diagram shows that valve closure causes extreme pressure spikes that are over 3 times the operating pressure. For a 1,000 kPa operating pressure in a SAGD wellbore, this means transients can be expected as high as 4,000 kPa. This is considerably over the fracture pressure of 1800 kPa. Over time, a fractured and dilated zone would propagate vertically.

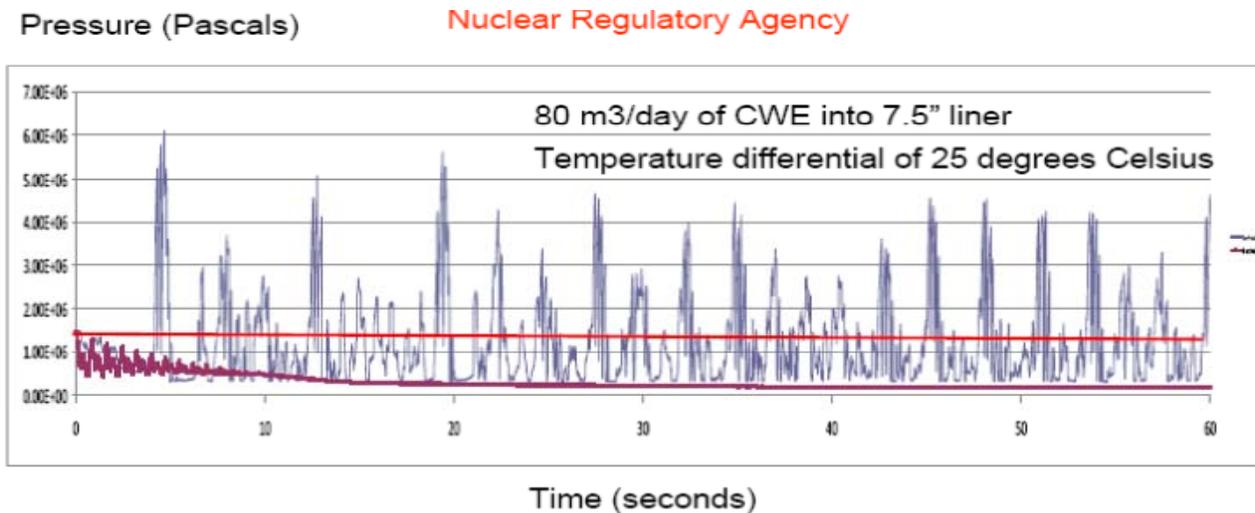
Figure-11 WAHA simulation of injection well – for first 60 seconds

Modelling has also been carried out using WAHA^{13,14,15} for an injection well utilizing an injection rate of 80 tonnes of steam a day with a 25° C temperature differential. The results are shown below. The wellbore has been simplified – only the horizontal section has been modelled. The liner has been simplified in that all of the fluid exits at the end of the well, where in reality there would be a distributed leakoff into the formation. The pressures are shown 75 meters from the heel of the well. The input to the model (such as heat transfer coefficients) was not tuned and only the first minute is shown. The blue line represents the pressure and shows short term transients of over 4,000 kPa. The well trajectory has been changed for the purple trace, with the objective of preventing CIWH. It is possible, with proper design, to eliminate these spikes. The red line represents the maximum pressure in the well. Above this pressure the formation will hydraulically fracture.

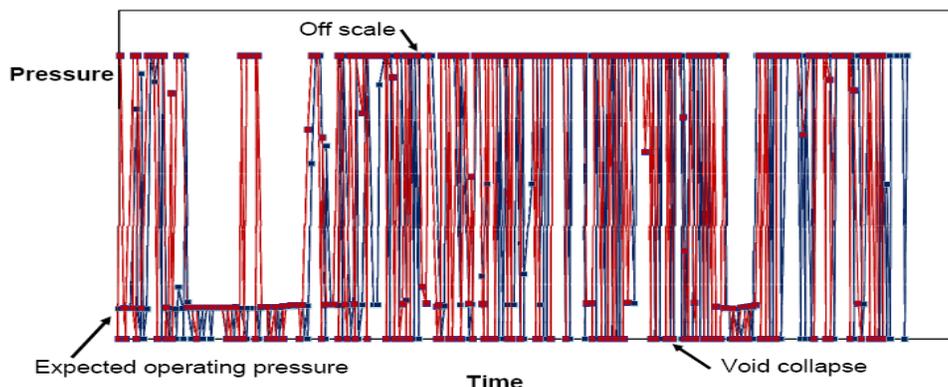
Figure-13 Cartoon of well pressure data. Red data is from heel, blue data is from toe

Observed data does exist, which has an appearance similar to that shown below. This data is problematical. The pressure sensors utilized were not sized to go to the pressure spike levels that occurred. The spikes are also very short, as shown by the modelling, and most pressure sensors are designed for long term averages. Note that both high pressures and void (zero) pressures are shown.

While conclusive proof is hard to draw from such data, the results obtained are not consistent with expectations. The data indicates pressure spikes more than sufficient to induce a hydraulic fracture. These events would logically involve relatively small volumes of fluid since the spikes are so short. It is clear that the process is repetitive.
