SPE SPE-156962-PP

An Analysis of the Caprock Failure at Joslyn

M.R. (Mike) Carlson, RPS Energy Canada Ltd.

This paper was prepared for presentation at the SPE Heavy Oil Conference Canada held in Calgary, Alberta, Canada, 12–14 June 2012.

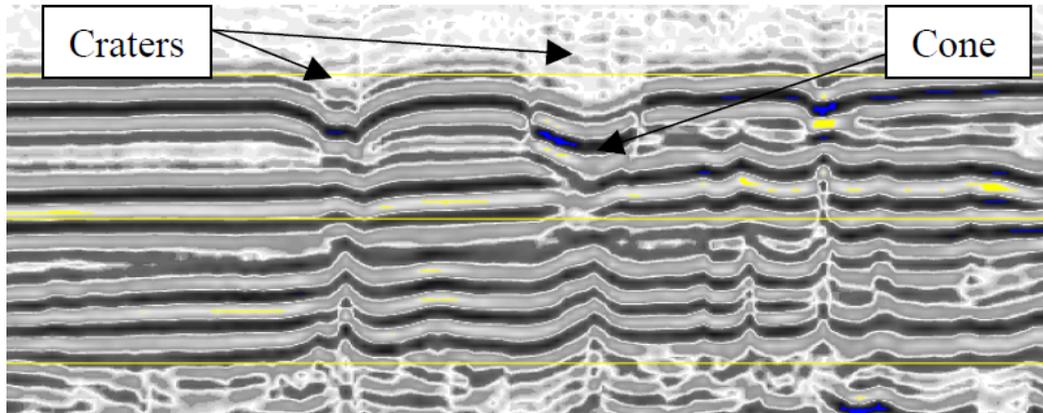
Figure-7 Seismic Picture of Gas Pipe in Nigeria

The structures found in Rhodes show vertically fractured pipes in poorly consolidated (can-be-cut-by-knife) argillaceous cap rocks. Natural processes do create vertical permeable zones in cap rocks and that they can be formed in relatively loosely consolidated cohesive claystones. This corresponds to high pressure fluids migrating upwards. A classic pipe caused by zero effective stresses. The above closely resembles the picture in Figure-4.

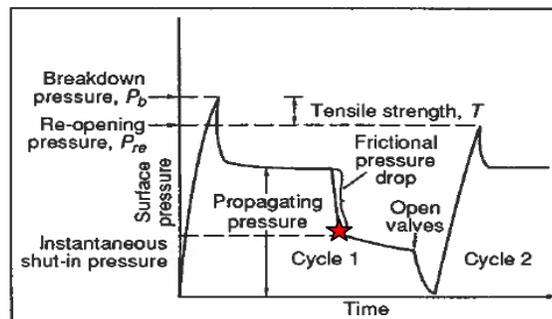
Figure-8 Fracturing Pressure Expectations

No fracture will be propagated if just the ISIP is reached (shown with a red star in the above). For the fracture to propagate additional pressure is required to overcome friction in the fracture, create a stress concentration at the tip and more yet to overcome tensile strength and actually initiate the fracture. From the diagram above, one must get to P_b , breakdown pressure. This is considerably above the ISIP. In practice, a 10 percent factor of safety, which is the historical norm for fracture pressure safety factors, actually has a huge margin of inherent safety.

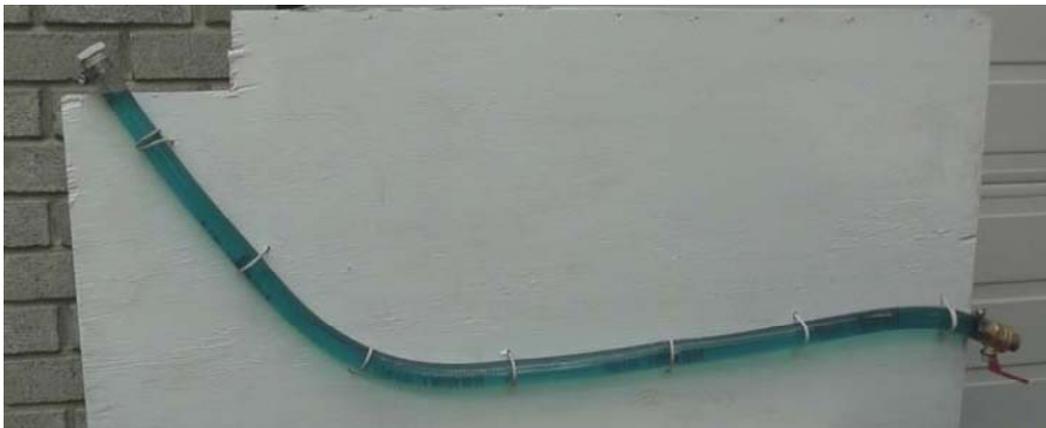
Figure-12 Physical model of water hammer in a SAGD injector

It is also possible to build some fairly simple physical micro-models using some vinyl tubing and a wall paper steamer. All of which can be purchased at a local building store for a nominal cost. With a bit of epoxy putty, the tubular arrangements found in SAGD wells can be cheaply constructed. This demonstrates that the geometry definitely exists for water hammer. The latter experiments are, of course, at a very low pressure, approximately 4 kPag. The author believes that CIWH is not intuitively obvious and this visualization is critical.

Because the riser section is typically gas (steam) filled, there is a large gas cushion effect and the downhole pressures do not manifest at surface. For instance, in the demonstration model shown in Figure-12, the wallpaper steamer operates continuously despite the downhole water hammers.
